THAMES RIVER BASIN
STAFFORD, CONNECTICUT

ELLITHORPE DAM
CT 00481

**PHASE I INSPECTION REPORT
NATIONAL DAM INSPECTION REPORT**

DEPARTMENT OF THE ARMY
NEW ENGLAND DIVISION, CORPS OF ENGINEERS
WALTHAM, MASS. 02154

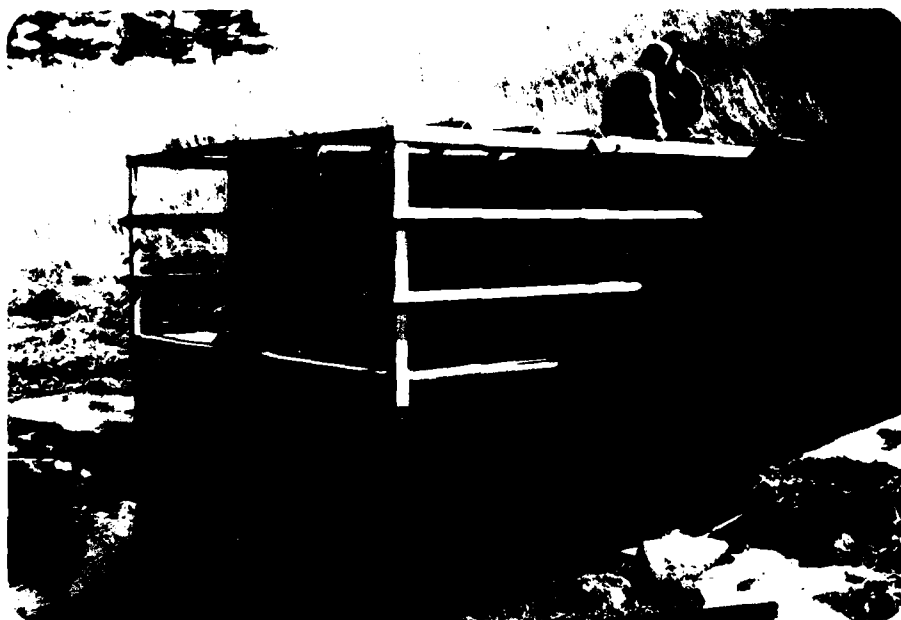
C-5 INLET STRUCTURE

1. Principal Spillway - Photo No. C-5 shows the inlet to the principal spillway. The inlet is a reinforced concrete riser with splitter wall and hooded inlet. An 8-foot by 1-foot slot opening is set at the elevation of the approach channel to carry low flows. Condition of the concrete and appurtenances is good.
